Retrieval of Rigid Metal Post and Esthetic Management of Anterior tooth- A Case Series

Abstract : The root canal treated tooth often requires post and placement. Prefabricated metal posts are still commonly used in clinical practice. Drawbacks of these metal posts include esthetic concerns, apart from their inherent rigidity. This case series showcases the management of teeth restored with metal post with fiber post and esthetic replacement of definitive restoration.

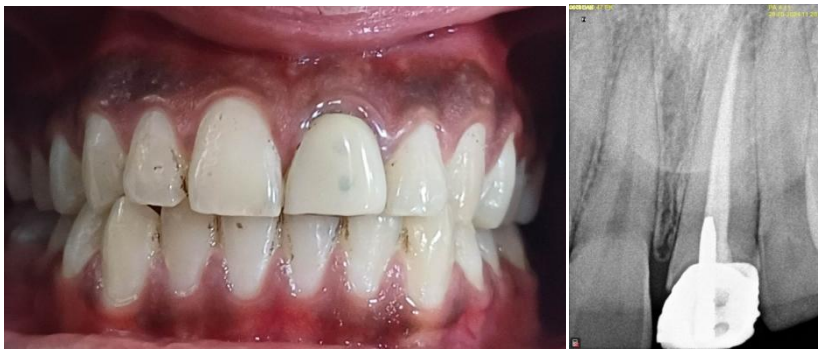
Clinical examination revealed display of color of metal through the porcelain fused to metal crown at middle one third of maxillary left central incisor (Tooth number 21). Radiographic evaluation revealed adequate obturation of the root canal with the presence of highly radiopaque structure extending till the coronal third of the root canal with respect to 21.

Fig.3.1.1 Preoperative

Diagnosis of Previously treated tooth restored with PFM was made with respect 21. Since the patient was asymptomatic, after explaining the possible outcomes for the tooth, treatment plan was made to remove the esthetically unappealing crown and metal post followed by restoring the tooth with fiber post and all ceramic crown.

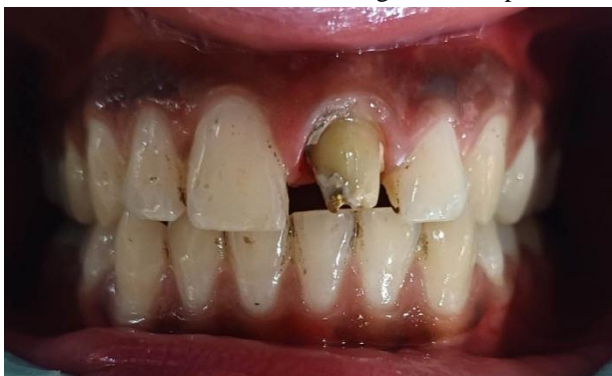
Fig. 3.1.2 Disassembly of crown

In the subsequent visit, crown was disassembled using diamond bur to cut the ceramic and transmetal bur to cut the metal. After the removal of the crown, it was found that there was adequate ferrule remaining. However, exposed metal post and faulty restoration was found. Using ultrasonic instrument, metal post was removed under magnification using DOM.

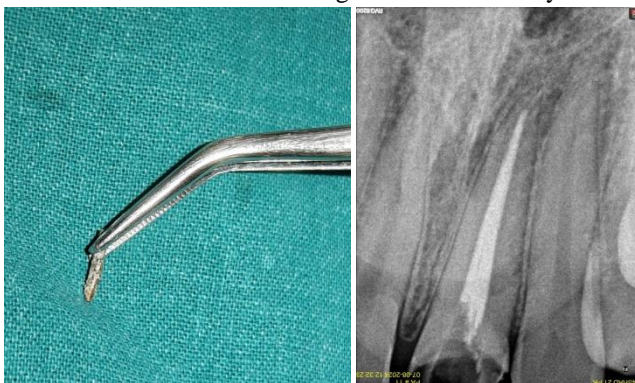
Fig. 3.1.3 Removal of metal post

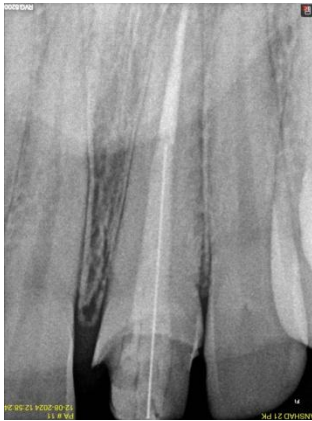
Fig.3.1.4 Fiber post and core build up

Following the post removal, post space was prepared and fiber post was bonded to the root canal and adhesive core was build. Pre-existing margins were refined to receive an All-ceramic crown. In the next visit, crown made of IPS E.max was bonded to the tooth 21.

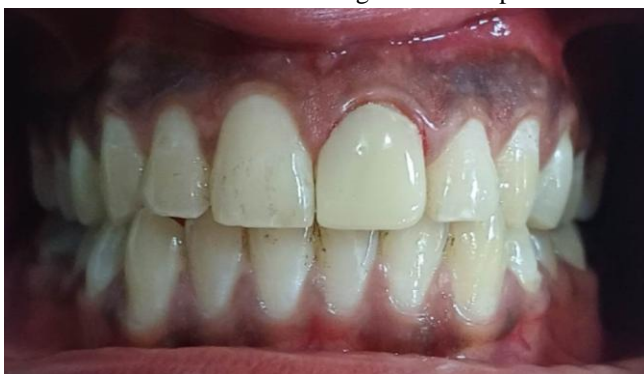
Fig.3.1.5 Immediate Post-operative

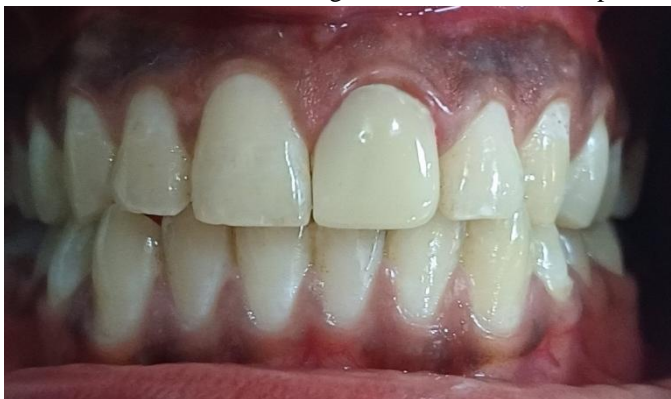
Fig. 3.1.6 Follow-up

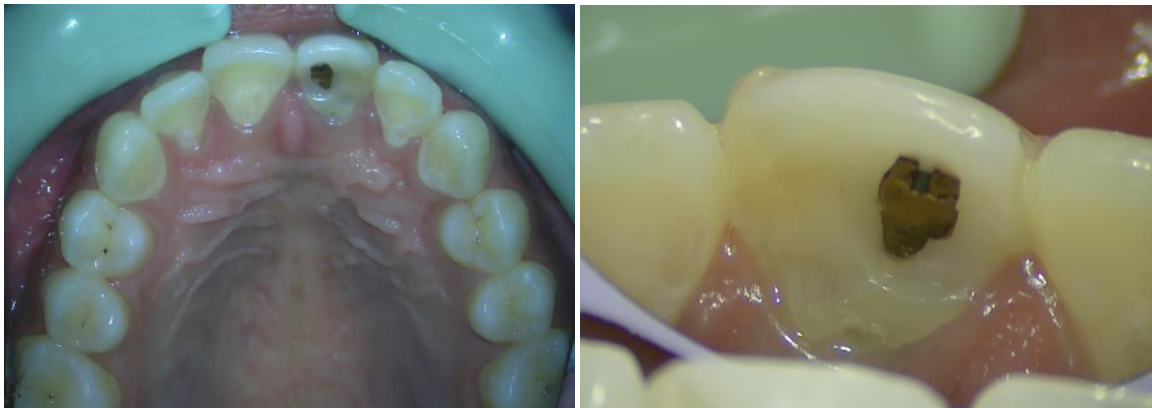
Clinical examination revealed display of color of metal post through the tooth at middle one third on the palatal surface of the maxillary left central incisor (Tooth number 21). Radiographic evaluation revealed adequate obturation of the root canal with the presence of highly radiopaque structure extending obliquely till the middle third of the root canal with respect to 21.

Fig.3.2.1 Pre-operative

Diagnosis of Previously endodontically treated tooth restored with metal post and composite build up was made with respect 21. Since the patient was asymptomatic, after explaining the possible outcomes for the tooth, treatment plan of removal of the esthetic metal post followed by restoring the tooth with fiber post and all ceramic crown was devised.

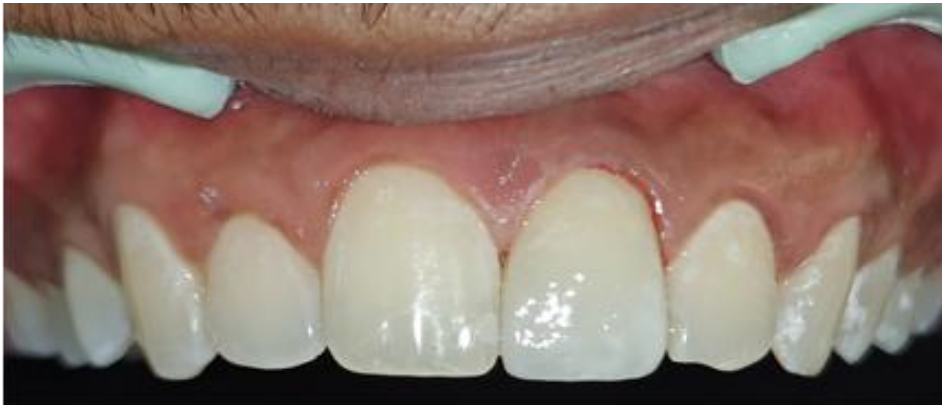
Fig.3.2.4 Immediate postoperative

Following the post removal, post space was prepared and fiber post was bonded to the root canal and adhesive core build-up was done. Tooth preparation was done and Zirconia crown was bonded to the tooth 21.

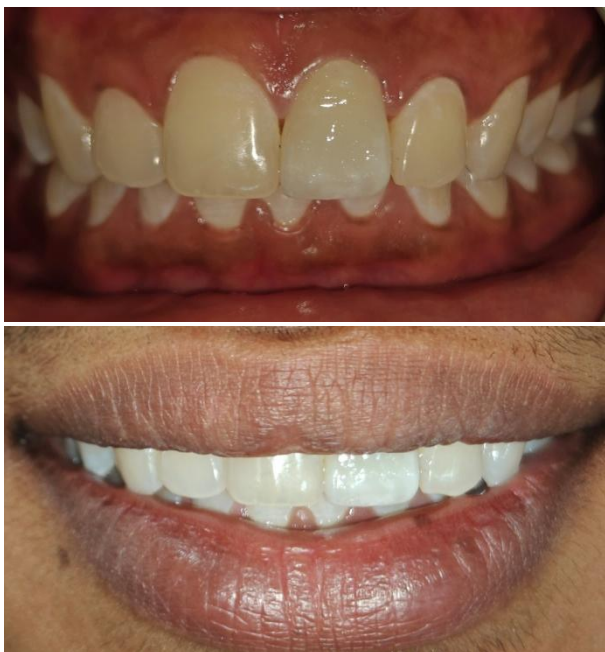
Fig.3.2.5 Follow-up photographs
